Standard Building Inspection Report

**For Daniel & Misty Chandler at 1004 NW Kingswood
Lawton, OK**

Report: 041807A (4/18/2007 - 1004 NW Kingswood)

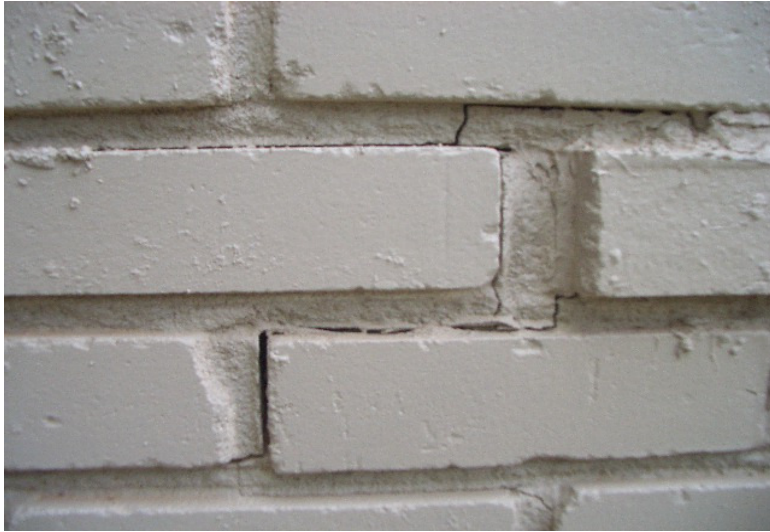
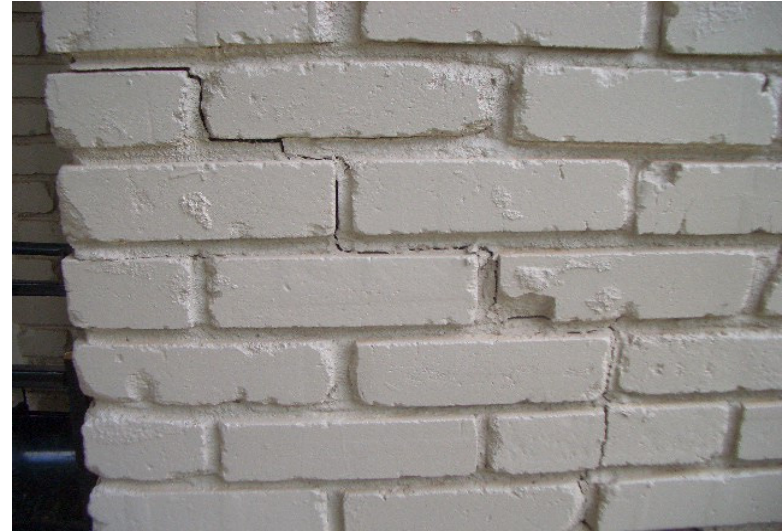
101. Visible Settlement: Minimal / Average Settlement

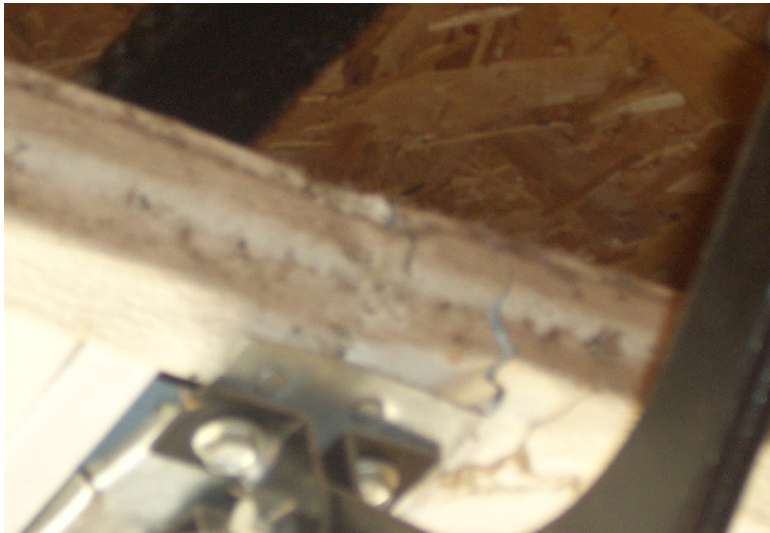
215. Damaged Garage Door Panels

Condition noted at upper panel of south garage door where opener attaches to garage door. See Picture

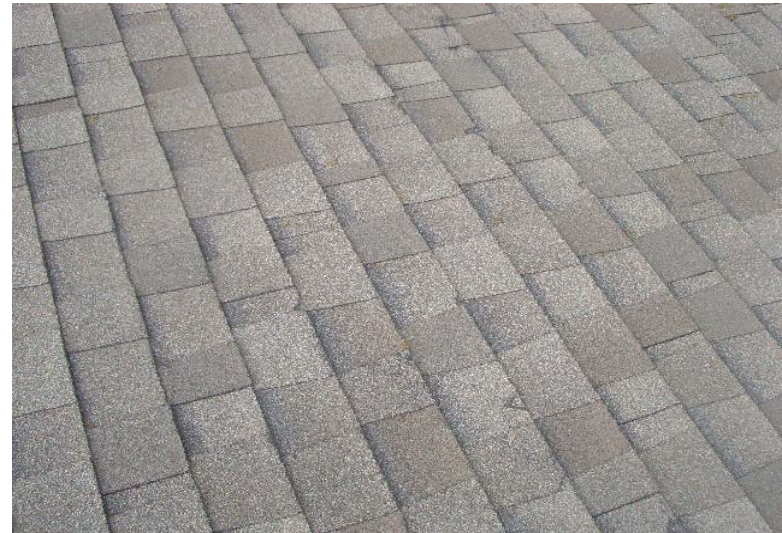
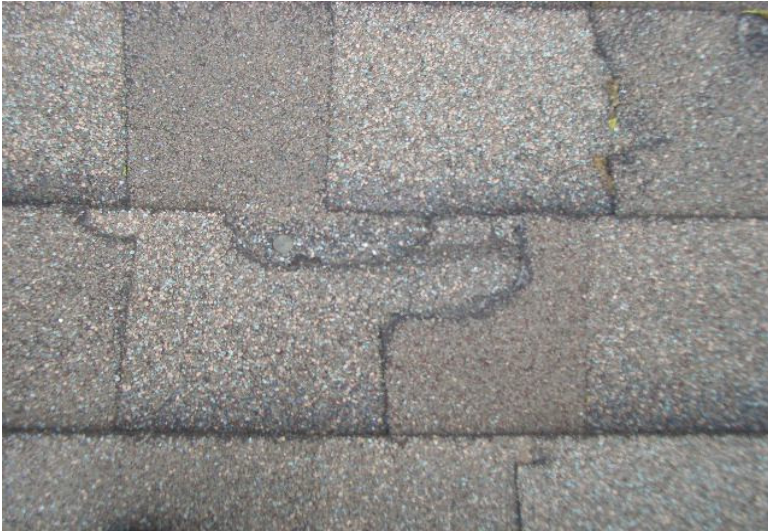
307. Prior Limb Contact Noted With Roofing Material
Repairs needed.

307. Prior Limb Contact Noted With Roofing Material

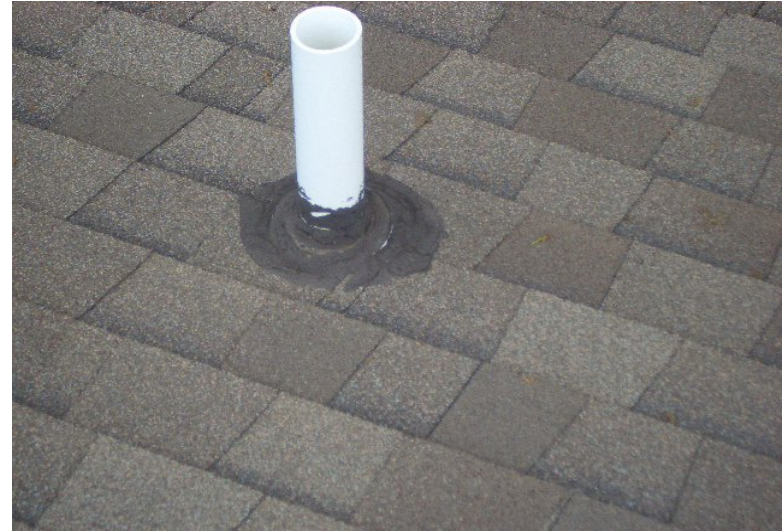
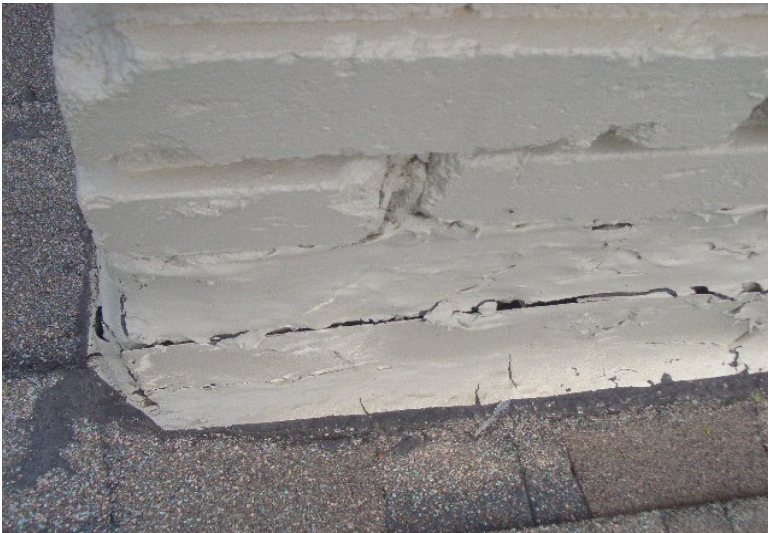
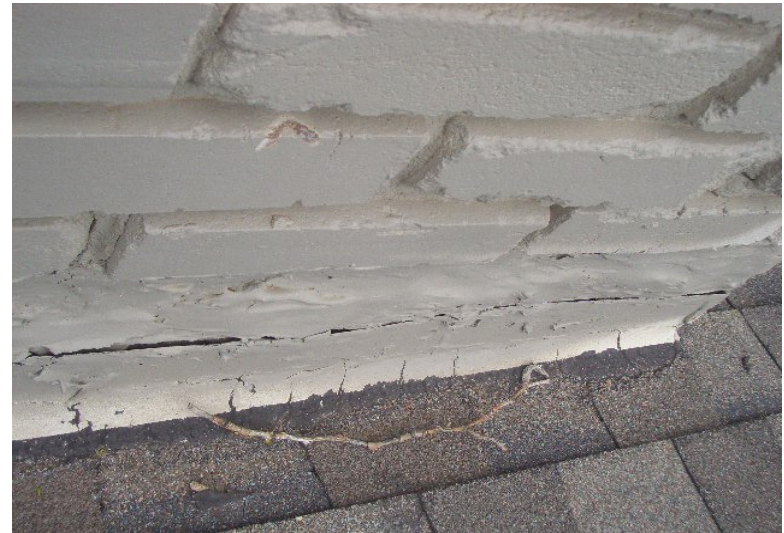
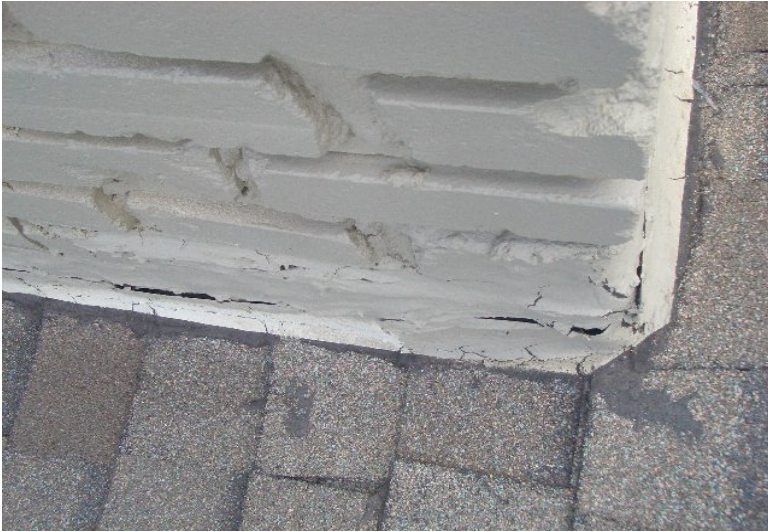
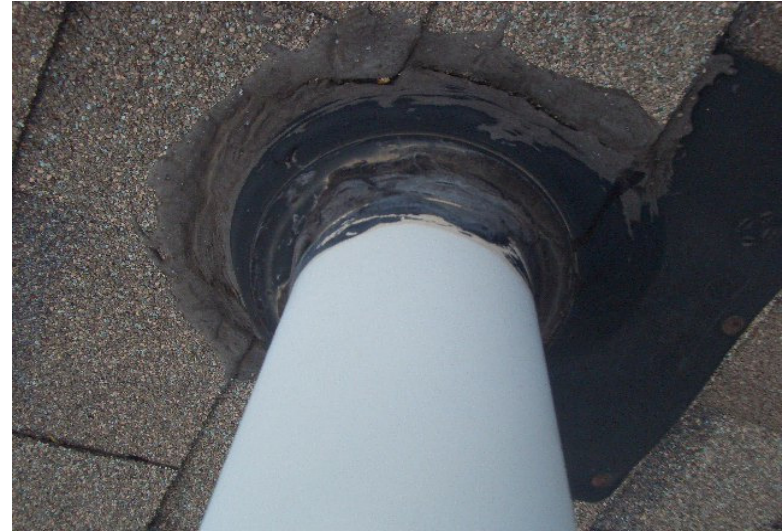
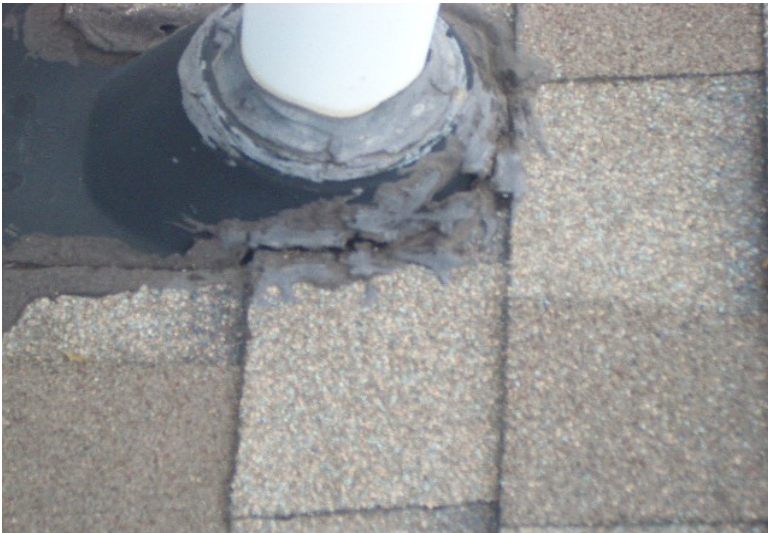
309. Open Seams noted at aged vent collars
Flashing for chimney stack does not appear to be completed and sealed into place. Suggest repairing and resealing seams.

309. Open Seams noted at aged vent collars

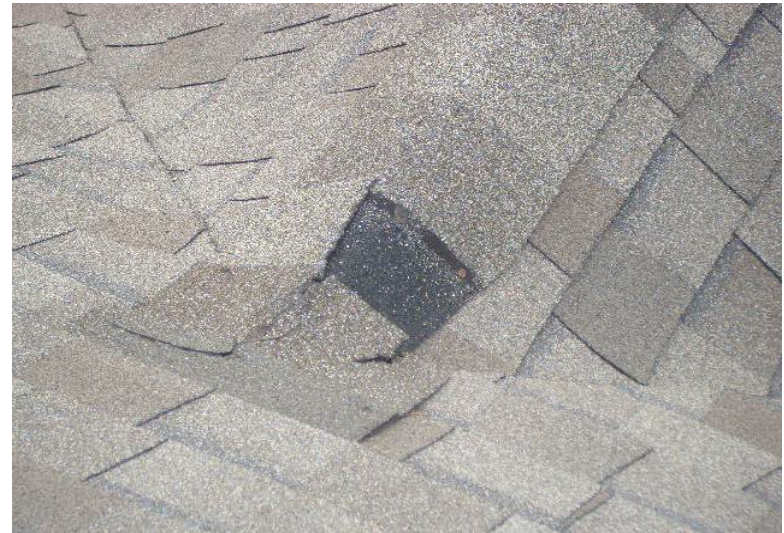
312. Surface Damage noted to roofing material
Surface damage noted to roofing materials due to wind.

312. Surface Damage noted to roofing material

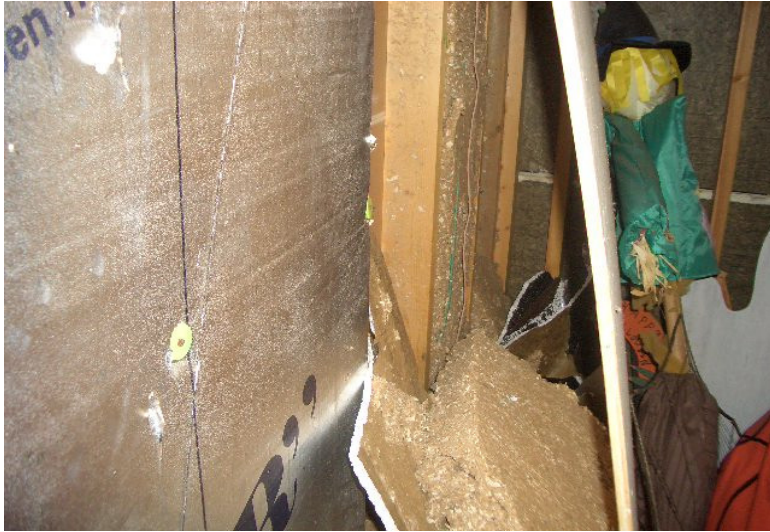
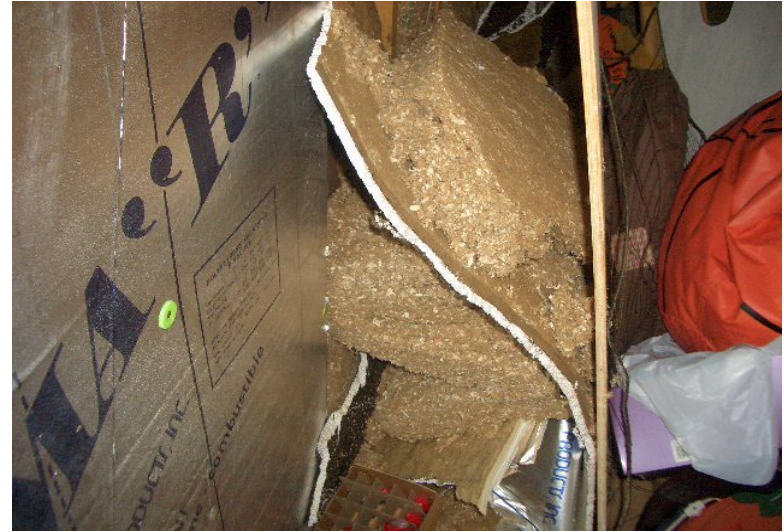
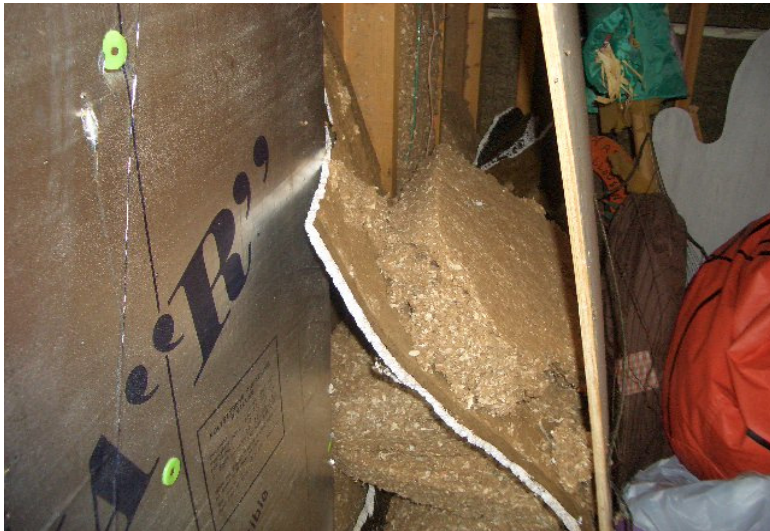
331. Dislodged / Missing Insulation Noted
Condition exists in attic area. See Picture

331. Dislodged / Missing Insulation Noted

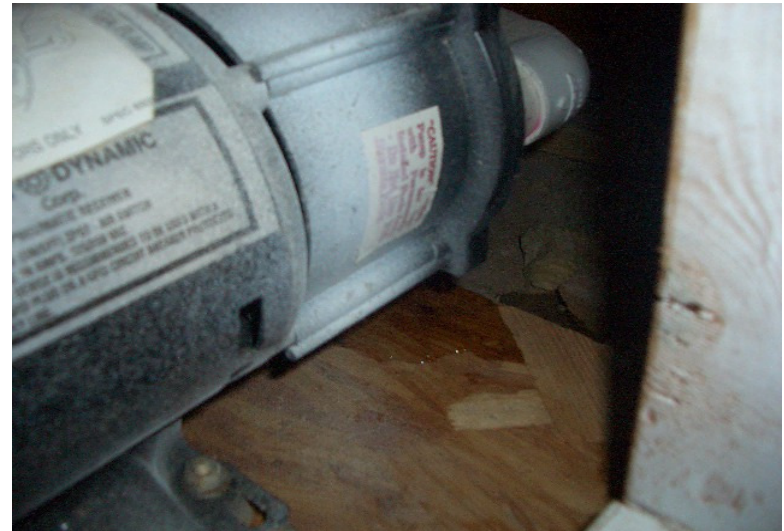
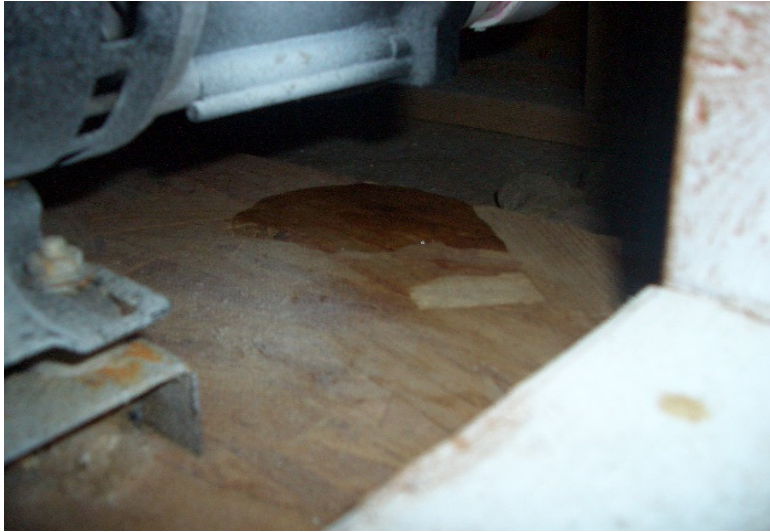
402. Leakage Noted At Whirlpool

Condition noted at master bathroom Jacuzzi pump. Possibly allowing jets to work intermittently. Repair/replace as needed

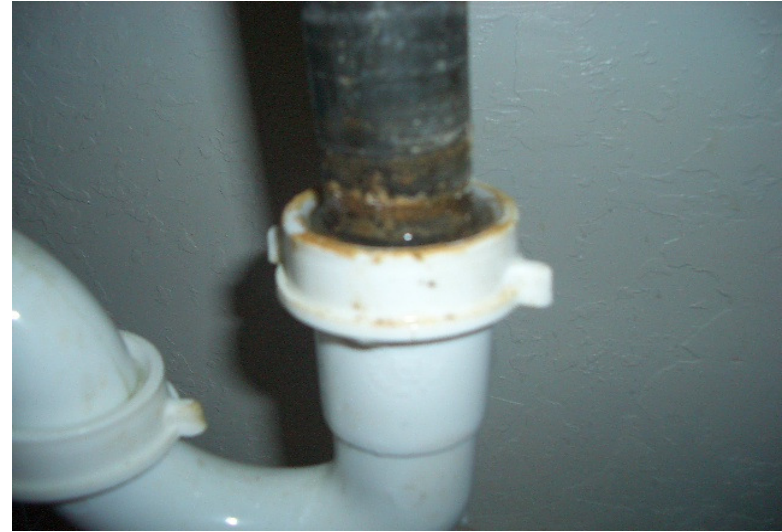
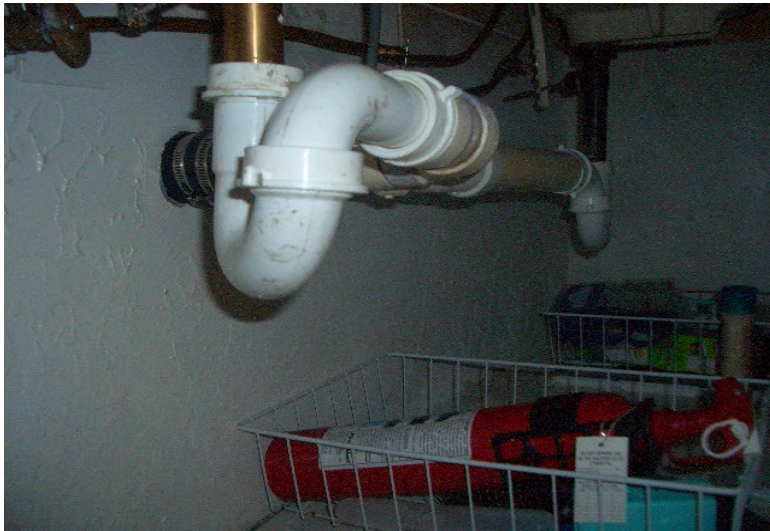
403. Leakage noted at drains/connections

Condition noted at drain connection at sink in upstairs hall bathroom.

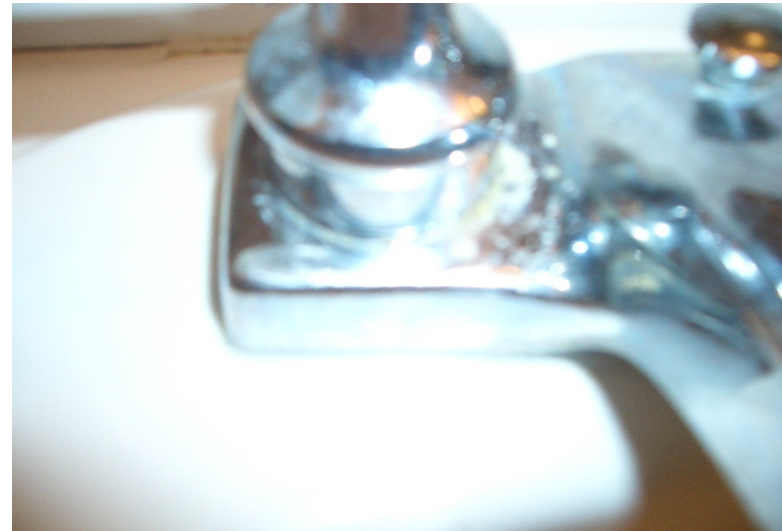
405. Leakage Noted At Base/Handle Area Of Faucet

Evidence of previous leakage noted. See Picture

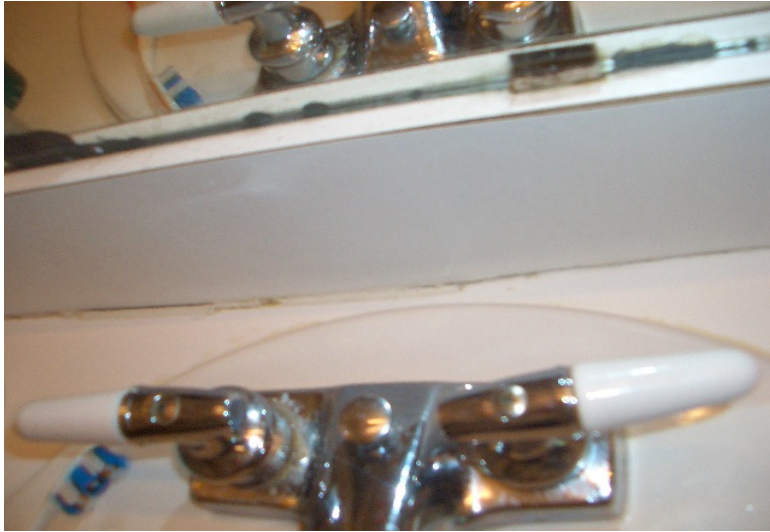
423. Caulking Suggested/Needed

Condition noted at counter top in upstairs hall bathroom..

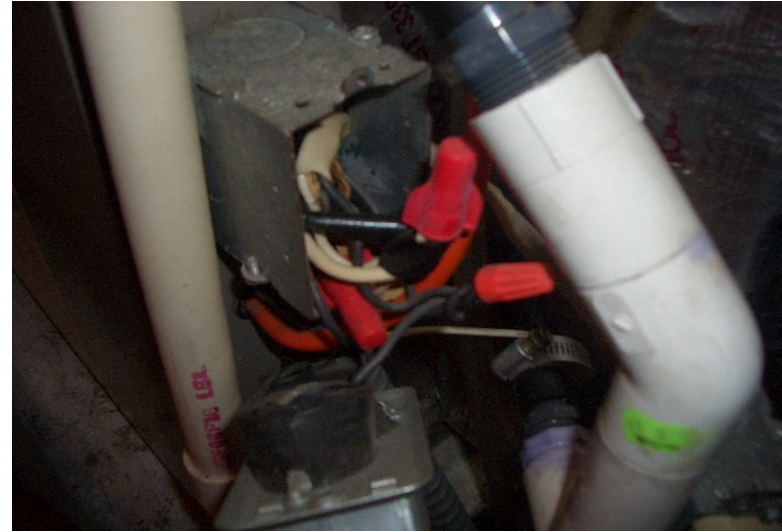
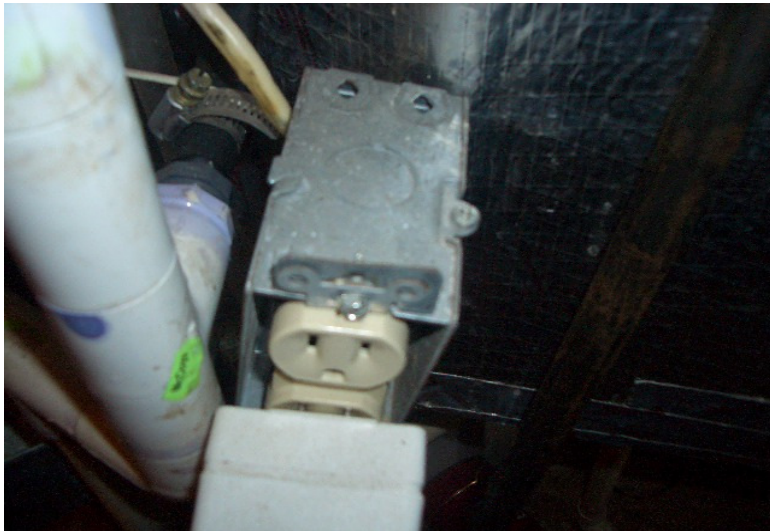
533. Open Junction Box / No Cover

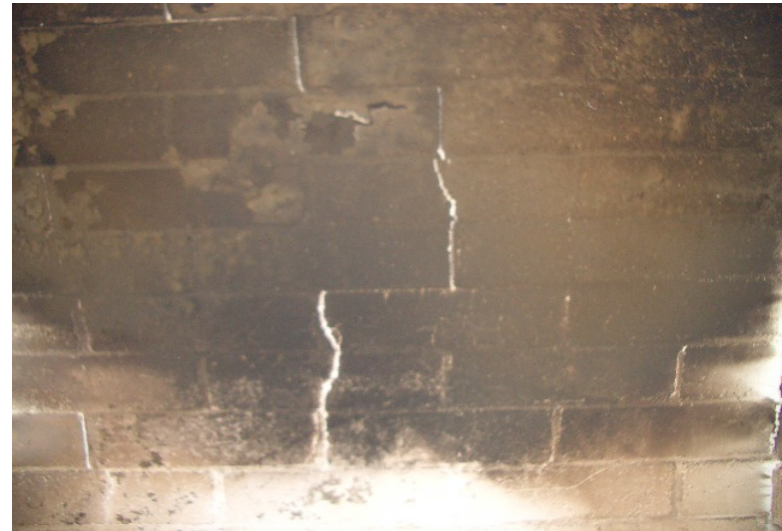
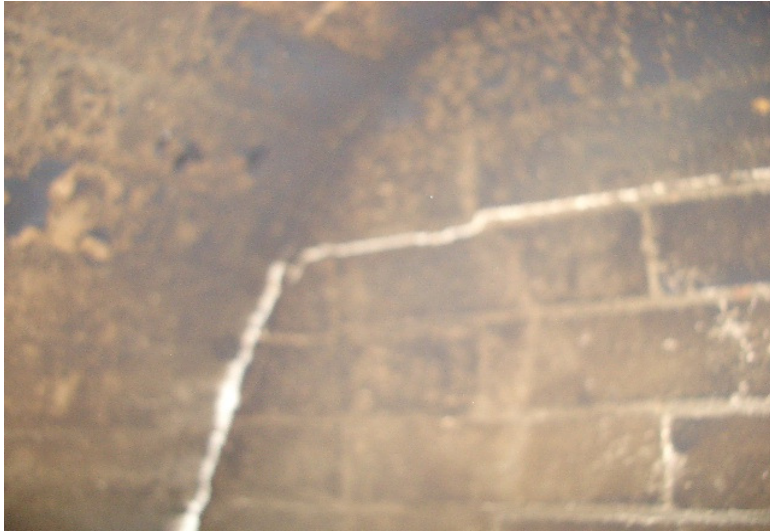
826. Defective Firebrick / Cracked Refractory Panel

Fireplace brick deteriorated. Evaluation by chimney sweep advised.
